Site Communication

One Page Summary of Incident Investigation Report

INCIDENT TYPE: Fatality

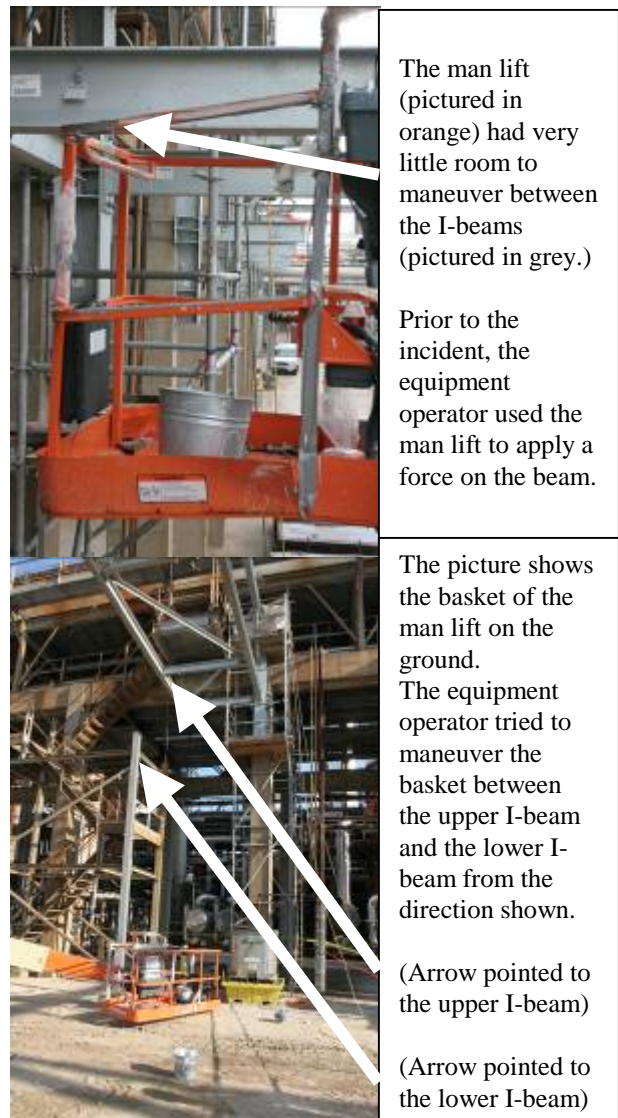
While operating a JLG brand aerial lift (man lift), a contractor employee was fatally injured when he was compressed between the platform control panel of the lift and a 10 inch I-beam. Although there were three co-workers in the area, there are no known eye witnesses to the actions leading up to and causing the fatality. According to testimony, the equipment operator was found in a compromised position by the co-workers.

1. The equipment operator maneuvered the man lift into a location which had numerous obstacles – it was a very tight space. There were only a few inches of clearance between the basket and the upper and lower I-beams. The immediate overhead obstruction required the equipment operator to lean forward/crouch/stoop in the basket to avoid being pinned between the control panel and the I-beam.

2. The equipment operator engaged the man lift controls at a speed and direction that pushed him into the I-Beam. The speed control knob was found to be at the highest possible speed which is improper when operating equipment where there are numerous obstacles and tight spaces. The safety interlock (locking ring below the handle) on the main lift/swing joystick located in the platform's control panel was circumvented and could allow the joystick to be engaged unintentionally.

The man lift policy, hazard assessment form and a pre-use inspection record have been updated to remind workers and supervisors that the equipment needs to be in proper working order and that equipment should be used only for its intended use (i.e. ensure safety devices are functional, do not exceed load capacity, etc.)
