# Double fatality due to explosion of a water-condensate tank

31-05-05, 09:00 a.m.

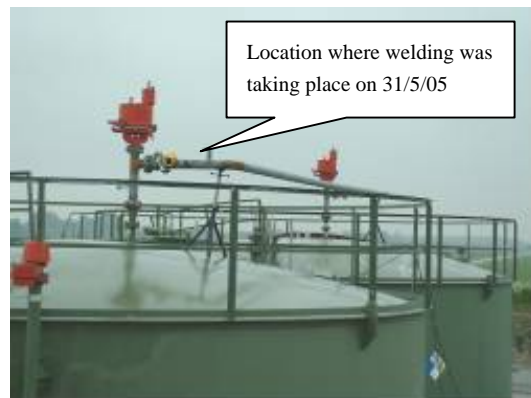
Partly installed pipe on roof before the accident (status 20 May 2005).

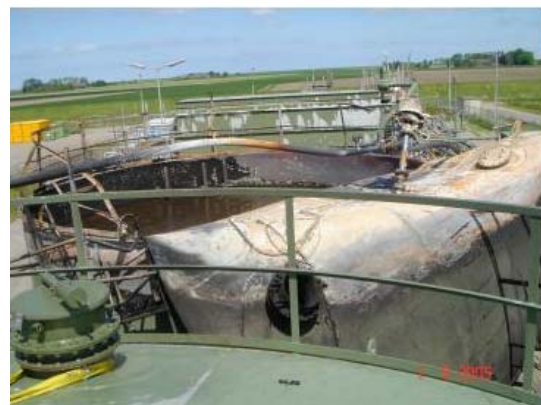
The tank explosion and subsequent fire killed a welder and a fitter working on the roof and injured two other persons.

- The tank contained approx. 170m<sup>3</sup> of water and 30m<sup>3</sup> condensate with oxygen ingress possible via the pressure vacuum valve and installed piping.
- Welding had taken place on the tank roof on the day prior to the incident as well as on the day of the incident. However, the direct ignition source has not been confirmed with absolute certainty.
- There was no positive isolation (spade) between the tank and new pipe work.

An overview of situation after the accident

The key controls preventing hot work in the hazardous area of the plant were not effective. Specific actions will be developed to analyse and improve the controls for:

- Hot work near tanks and vessels with hydrocarbon inventory,
- Positive isolation,
- Work permits.
