Project Location: UK

Brief description of Incident - Broken quick hitch link

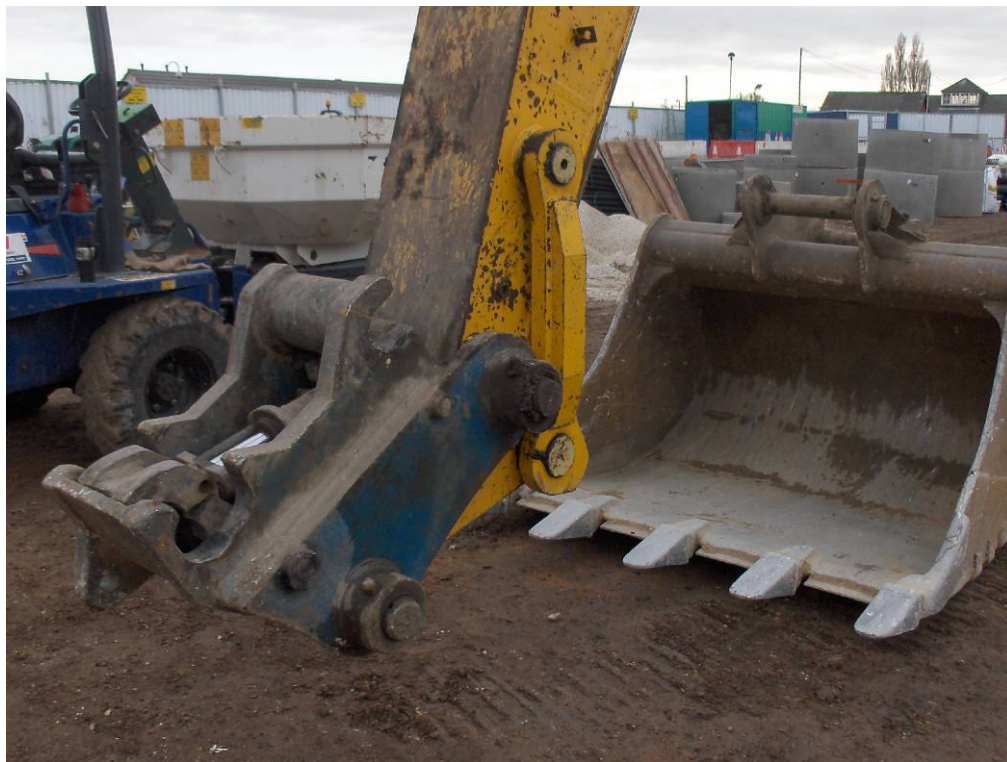
Bucket & Arm

During activities using a 1.5M³ bucket on a 360° JS330 the plant operator heard a noise emanating from the vicinity of the quick hitch linkage (Hill's quick hitch). The operator ceased working with the bucket and released the bucket to investigate the cause of the sound.

Works stopped immediately.
Investigation into incident convened with the plant provider.
Request made to supply all maintenance and inspection documentation

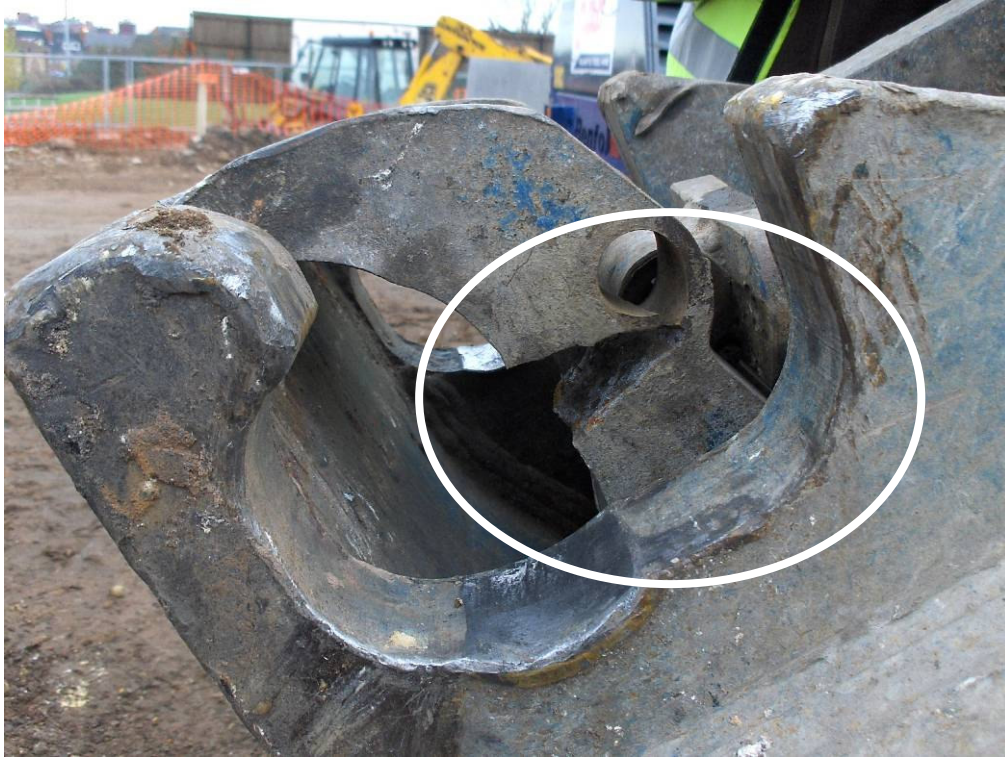
The investigation revealed a serious crack within the link (see photos), the machine was removed from service immediately.

Fracture Cast Link
