Project Location: Manchester, UK

Brief description of Incident

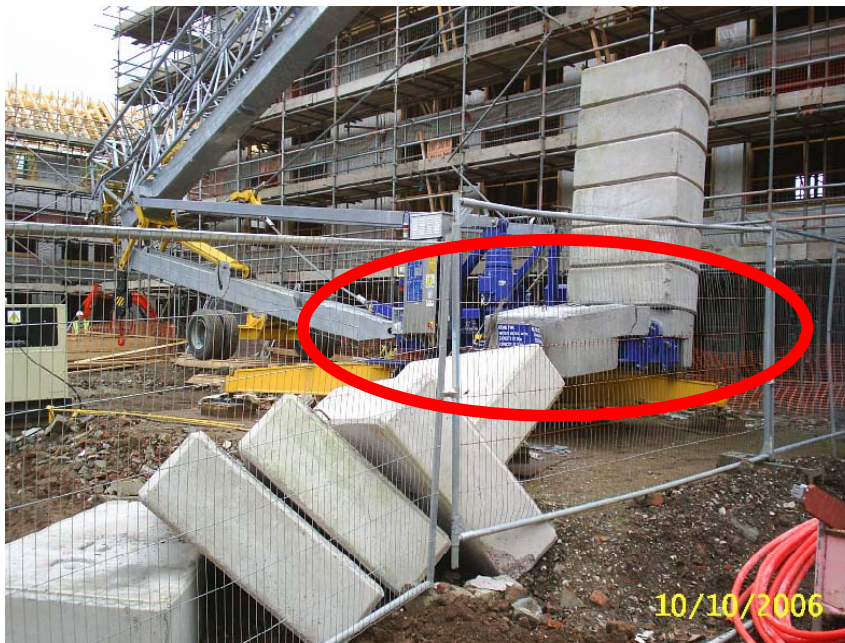
In dismantling the crane, a crack which had been known to be present for some time on the platform base opened up further resulting in failure on the left hand side of the platform base block which subsequently brought down the remaining blocks on this side of the ballast pile.

Photo 1
Crack in
concrete and
fallen ballast
blocks.

The photographs detail that there was a significant crack formed in the ballast, which had further opened when it failed.

- “The failure of the ballast base block and associated collapse of the ballast stack was due to structural failure of the reinforced concrete base block”. “The reinforcement was incorrectly positioned within the concrete section during manufacture thereby reducing the effectiveness of the section to resist bending moments induced by the upper ballast blocks”.
- “On examination of the structural drawings for the Type 1 ballast block, we would have reservations that the reinforcing bars specified is adequately sized and correctly detailed for a section supporting over 10.5 tonnes of ballast on each side plus its own dead weight”.

- “A short term remedial solution for cranes currently in service is employed and that 3 No enhanced steel box sections be fitted to the underside of the crane chassis beams to provide additional support to the ballast base section”, as fully detailed in their report.

- “Recommend that all existing ballast blocks are thoroughly checked for defects by a qualified structural engineer (having removed all upper ballast first). Where there is evidence of structural cracks the ballast should be discarded. It would be prudent to consider replacement of all ballast blocks on existing cranes with products designed, tested, and quality certified by the manufacturer”.

- “Recommend that Mantis Crane Ltd examine steel support pads for the concrete base block to rest on. A rubber bearing strip placed between the steel and concrete would ensure a better contact area and reduce “hard points” and concentrated stresses on the ballast element which could possibly damage and over-stresses to the concrete”.

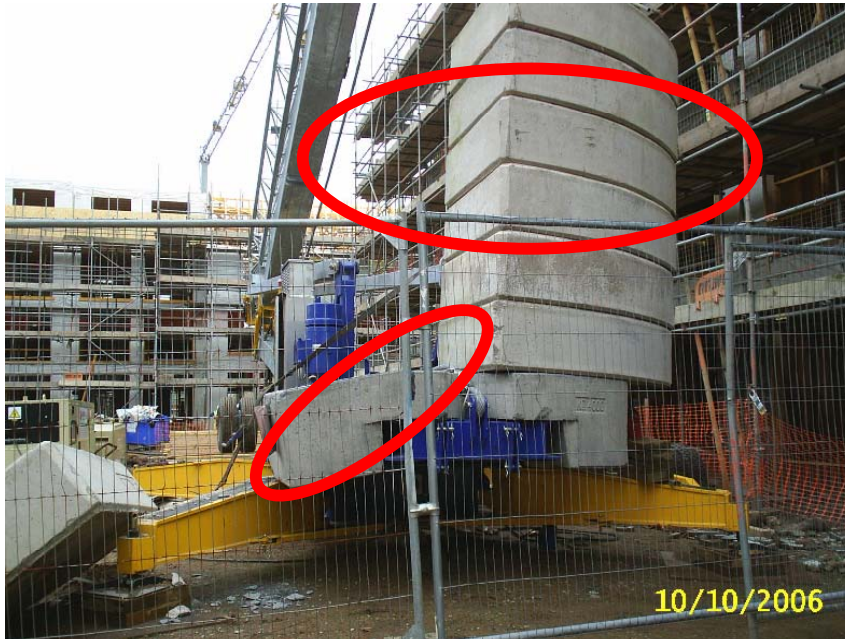
As a result of this failure, the crane was left unstable.

Photo 2
Crack in
concrete and
unstable
ballast
blocks.

- “The reinforcement bar arrangement had been incorrectly positioned in the concrete and this greatly compromised the effectiveness of the section to resist shear forces and bending moments induced by the weight of the ballast”.
- “The cover to the top reinforcement was 70mm” although the reinforcing bar was bent to allow 35mm to the top and bottom surfaces.
