Failure of Gas Cartridge Fire Extinguisher

Description of event

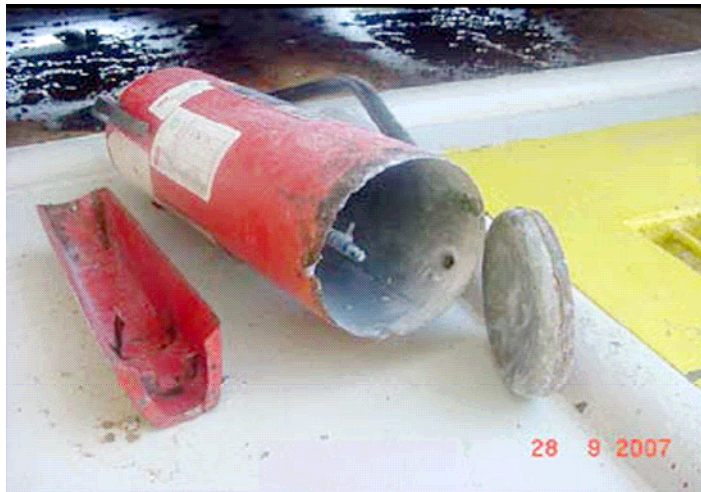
Photograph of fire extinguisher

A fatal injury occurred in Indonesia resulting from the operation of a gas cartridge type dry chemical powder filled fire extinguisher. Upon activating the fire extinguisher, the bottom of the extinguisher body failed. The fire extinguisher propelled upwards and struck the fire extinguisher operator in the neck and chin area resulting in fatal injuries.

There were signs of corrosion on the base of the extinguisher - it is thought that this may have contributed to the fire extinguisher failure. As a precautionary measure it is advised that all cartridge type fire extinguishers (in simple terms those which do not have a pressure gauge attached) should be inspected immediately. Those which show signs of significant corrosion or severe pitting should be removed from service and replaced.

Visually inspect all gas cartridge operated fire extinguishers that are located in potentially corrosive environments. Please check for signs of significant corrosion or severe pitting on the body and base of the fire extinguisher. Where there is a sign of corrosion or severe pitting on the extinguisher, take the extinguisher out of service immediately and replace it with a new unit.

During inspection, accessories such as rubber bases or mounting brackets should be removed to ensure a complete visual examination of the unit. If you are in doubt to the severity of the corrosion, take the extinguisher out of service and have it tested in line with manufacturer's guidelines. Potentially corrosive environments include:
