Project Location: UK

Brief description of Incident

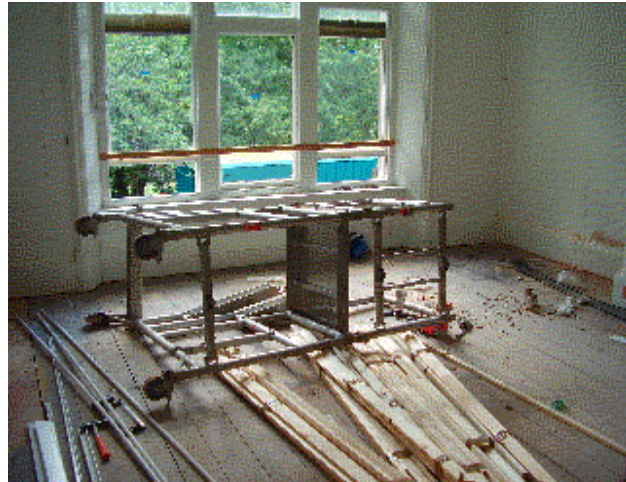
The podium fell to the floor, but as the electrician fell to the floor he also struck his forehead against a wall just above floor height.

On examining the podium several issues were identified. None of the four wheel locks had been engaged; the guardrail had not been raised to suit the (adjustable) platform height of 1.25m; a diagonal brace (normally attached between the two side frames) had not been fitted, it remained in its stowed position. The podium was also in a generally poor condition, with some parts not moving easily, and other parts clearly misaligned/bent.

Without the diagonal brace in position, the podium is prone to leaning or 'sagging' to one or another side by approximately 50mm. Whilst this tendency alone will not make the podium overturn, combined with the poor maintenance and the unlocked wheels these factors definitely contributed to the overturning.

What most probably happened at the time of the accident is that the podium leaned to one side, probably due to the electrician moving to one side of the platform. As his weight was thrown further over the side of the podium by the unexpected movement, his momentum together with the wheels being unlocked caused his weight to move outside the balance point of the podium causing it to overturn.

Whenever a contractor brings podium steps to site, a tool box talk on their assembly and use must be carried out, for each type in use. This tool box talk must also be recorded.

- Users instructed in assembly and use
- All podium components fitted
- Outriggers extended (If fitted)
- Platform gates closed and locked (these sometimes contribute to stability)
- Wheel locks engaged
- Podium positioned to avoid overreaching
- Guardrails adjusted to suit platform height
- Podiums inspected regularly
