# Site Safety Alert

## PILING RIG INCIDENT

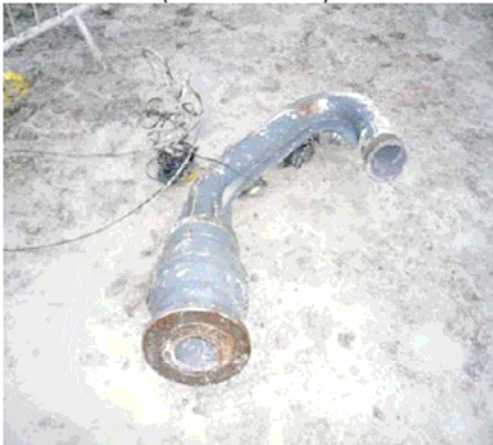
Picture No 1(Swivel head)

A serious 'Near Hit' occurred at one of our sites involving a piling rig, where the 'Swivel Head' (picture 1) detached itself from the 'Kelly Bar', (picture 2) and fell approximately 10 to 12 metres in height from the piling rig.

On inspection it appeared that 8 No bolts had sheared off, detaching the 'Swivel Head' from the 'Kelly Bar', and fallen to the ground.

All sites with piling rigs to ensure that this area is thoroughly inspected, especially the bolts holding the swivel head to the Kelly Bar, and that the mandatory 2 metre exclusion zone is observed around the auger.
