**Project Location: UK**

**Brief description of Incident**

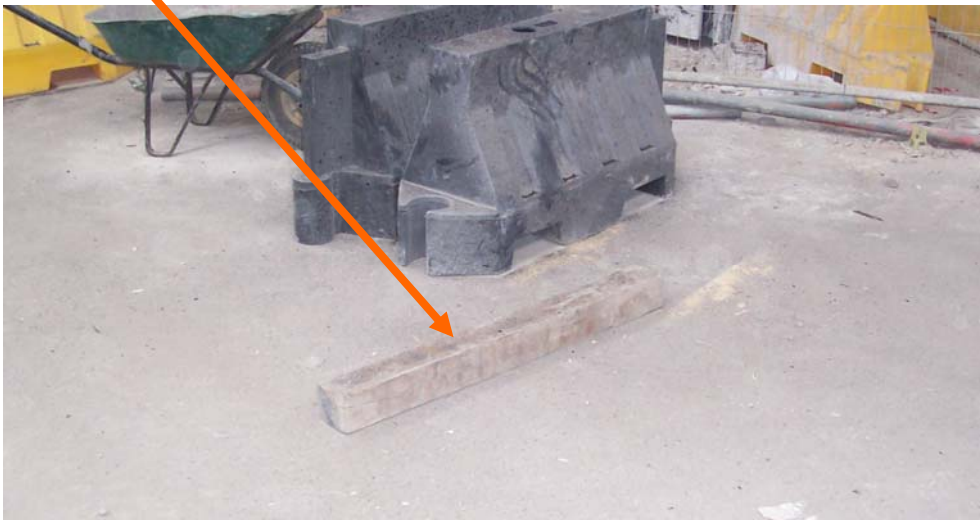
A 1m long 3"x3" batten fell from the scaffold missing a demolition worker by about 2m. The batten was used as a bearing pad between a prop on the scaffold and the underside of the roof structure. The vibration generated by the roofers caused the baton to become loose and fall.

The batten that fell in the position that it landed

The timber batten should have been nailed through the prop to prevent any chance of it falling. In addition the batten was unnecessarily long for the job.

The Scaffolders cut the batten down and shortened the other batten that was still in place before replacing them both and using a nail to prevent them from falling again.

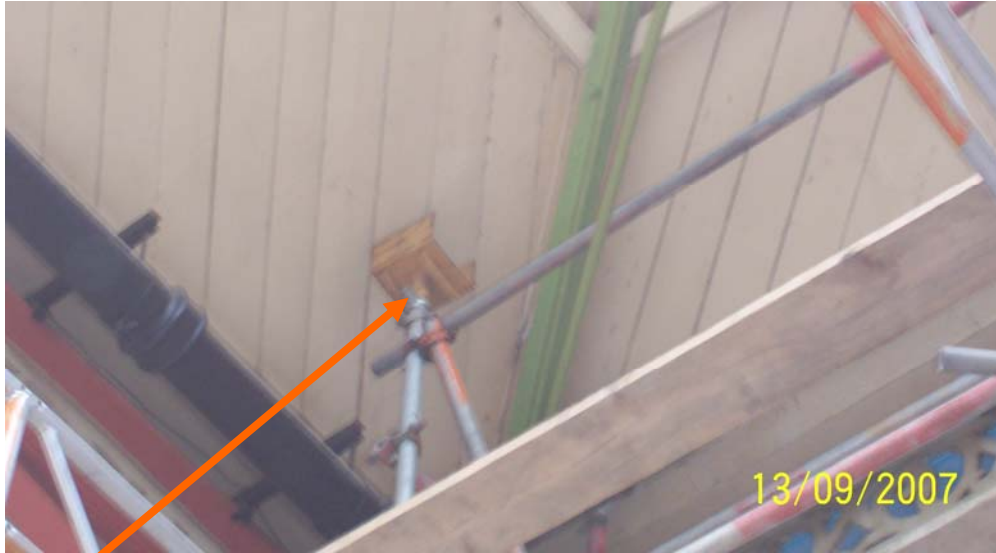
Another batten still positioned to the underside of the roof
