Failure of Waterstop Barrier Connectors

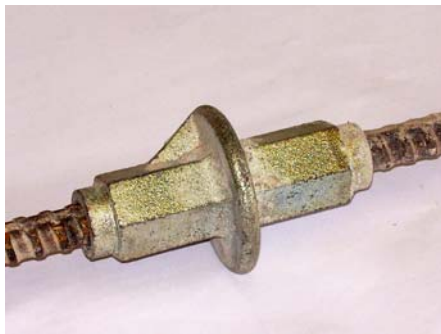
Undamaged Connector

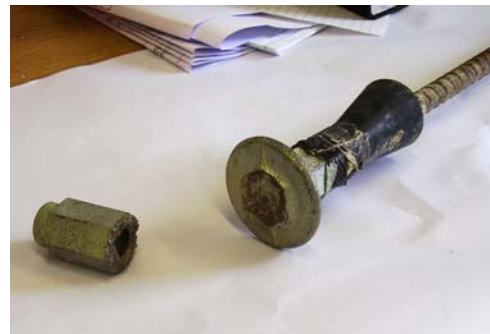
The investigation revealed there was no problem with either workmanship or the pour rate but found that the 2 no cast centre waterstop connectors had failed as demonstrated by the pictures.

Failed Connector

- You must check whether you have any connectors of this type in use on your project.
- If you have, remove them from use immediately and contact Phil McDonald of Midland Construction Supplies at phil@mcs-ltd.org who will arrange for their collection and supply an alternative product.

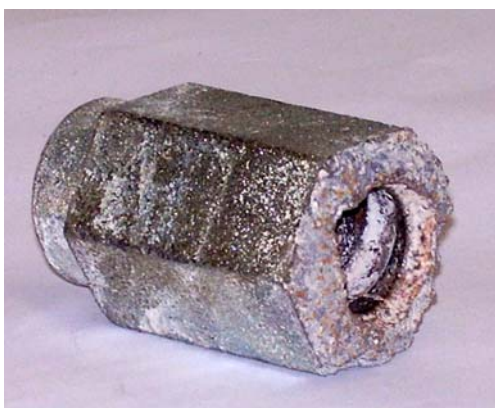
Detail of Failed Connector

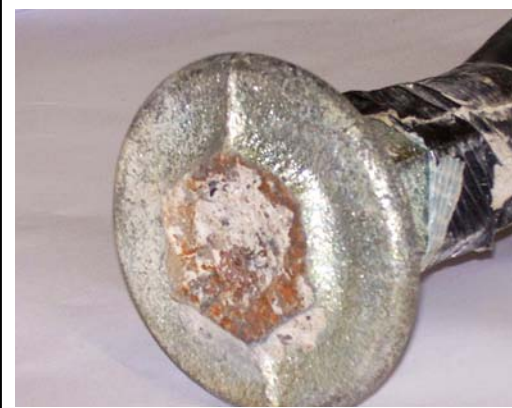
Detail of Failed Connector
